Manhole Inspection Summary

Manhole # S61Q__004MH

Insp Date: **12/17/08 11:34 AM**

Location Address: **4900 S. Ponca St.** Cross Street: **1200 Boston St.**

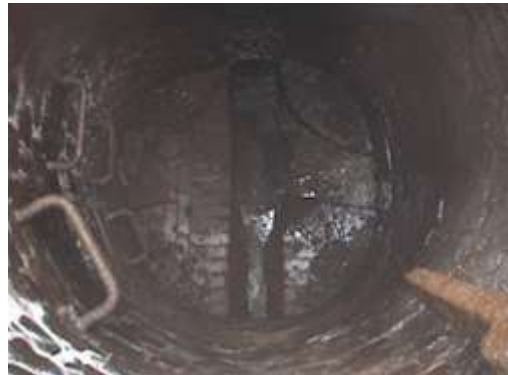
Top View

Comments **HIGH TRAFFIC IN THE MIDDLE OF AN 4 WAY INTERSECTION. wall, mortar, joints, bricks falling in to manhole**

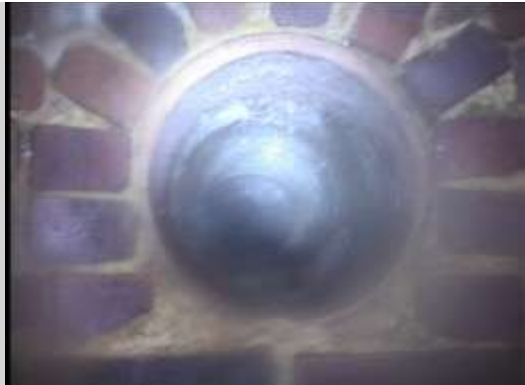
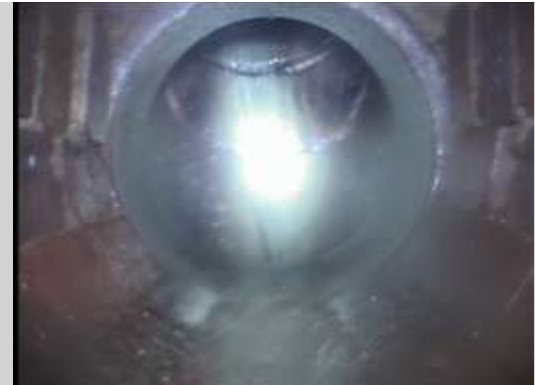
6 O'Clock Inflow

Pipe Height: **10.8** (in.) Rod and Bar (Angled)

Infiltration: **None** Pipe Seal Cond: **Sound**

Drop Condition: **Open**
